Project Profile: Mayorhold Car Park

Project: Mayorhold Car Park Refurbishments

Client: BCAL Consulting

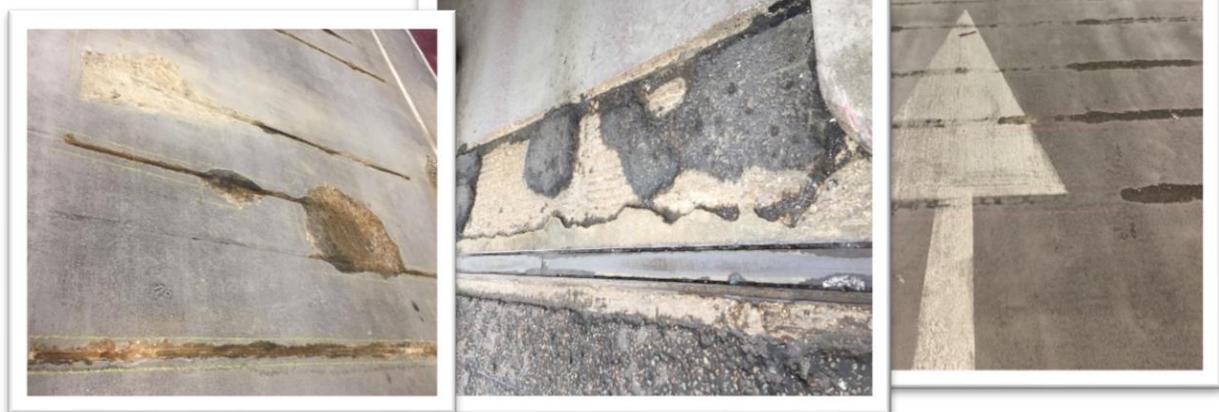
The project: The Mayorhold car park is a multi-storey long-stay car park situated in Northampton city centre, containing over 1000 spaces. Originally constructed in 1973, with refurbishment works carried out in 2006, this car park was again in need of remedial attention. **APA Concrete Repairs Ltd** were instructed to survey the car park in early 2018 which identified defects to the top screed of the car park surface which appeared to be of poor quality. As a result, several heavily trafficked areas of the car park had spalled and broken up, in some areas exposing cables and connections of the now defunct cathodic protection system that had been poorly installed in 2006. **APA** were contracted to undertake concrete deck repairs to several levels of this multi-storey car park.
