Project Profile: Esholt WWTW

Project: Esholt WWTW, Primary Settlement Tank Repairs

Client: Yorkshire Water PLC

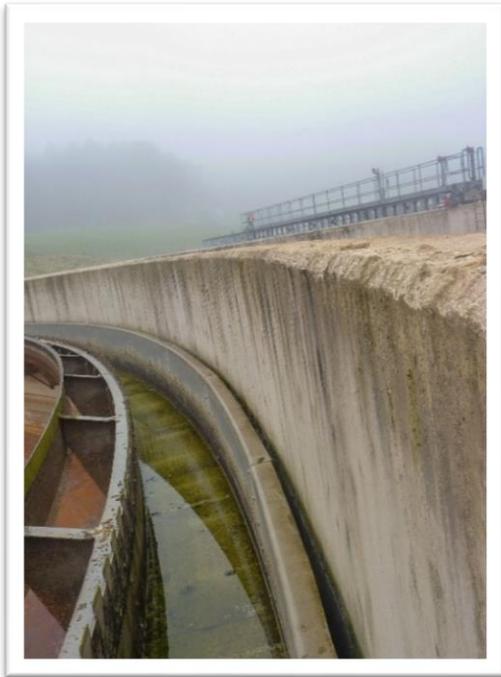
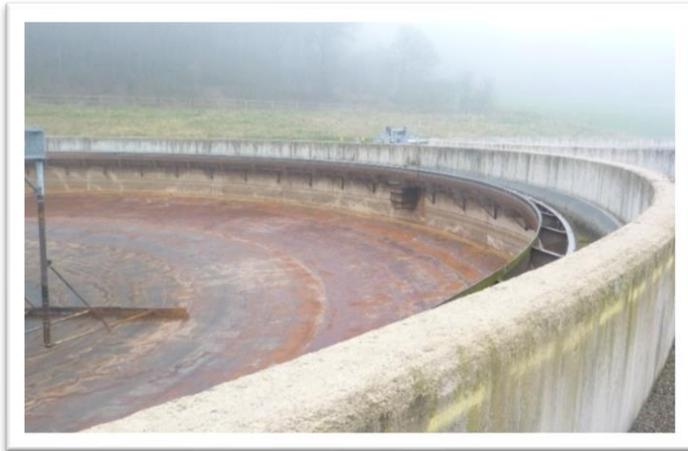
The project: Yorkshire Water (YW) were enduring problems with deterioration to their Primary Settlement Tanks (PSTs) within Esholt Waste Water Treatment Works in Bradford. The PSTs had been recently constructed as part of the Freshwater Fish Directive Scheme under Yorkshire Water's AMP 5 (Asset Management Plan). Two PSTs were showing signs of wear, particularly the tops and sides of walls where the concrete was friable and had broken down at the surface to leave an exposed aggregate finish, particularly around the line of the agitator boom running wheel where a running groove had formed in the top of the concrete around the wall tops.

The solution: Reforming and maintaining the original profile to the tops of the walls was of paramount importance due to the alignment requirements of the running wheel to enable the agitator boom to run around the circumference of the tanks all year round as well as the obvious loading and wear resistance associated with it. **APA Concrete Repairs Ltd** devised a programme of repair and protection works that included the installation of fixed scaffolding inside each tank, surface preparation of the walls using their Quill Dustless (wet) Abrasive Blasting system, before applying a specialist re-profiling mortar to the walls, a hard wearing epoxy mortar to the wall tops (the running surface) and subsequently a protective coating system over the top.

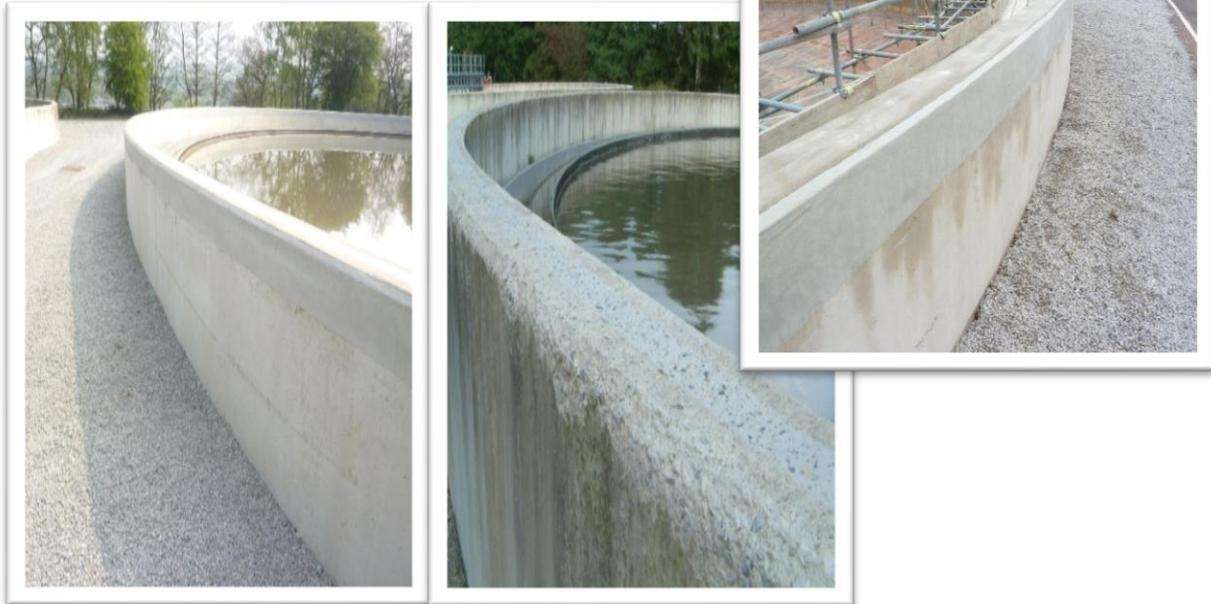
The outcome: The concrete walls to the two PSTs were successfully re-profiled, with the tops of the walls provided with a level running surface with an anti-slip finish as had been desired by the Client (YW). The protective coating system added increased durability to the repaired wall tops and increased the service life of the tanks thereby reducing future 'life cycle' maintenance costs.
