# Project Profile: Arlington Business Park

**Project:** Arlington Car Park, Concrete Repairs & Surfacing

**Client:** Workman LLP

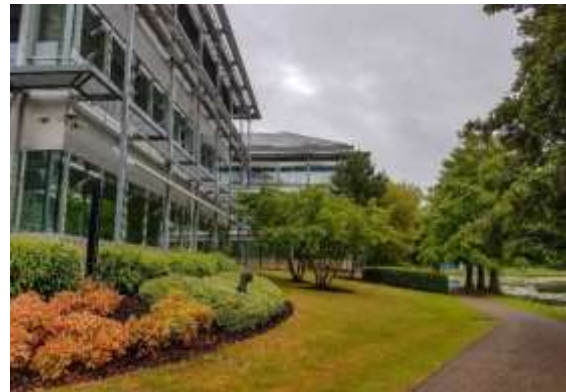
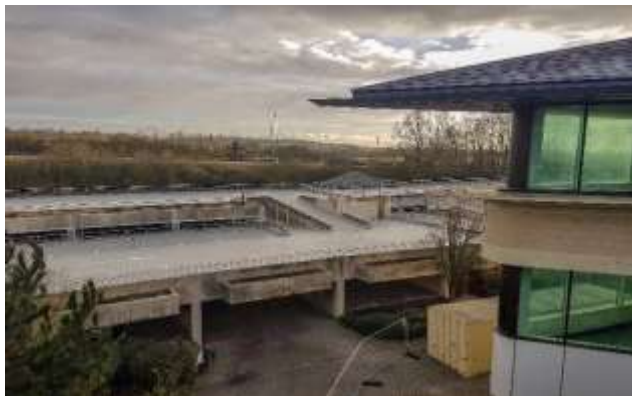
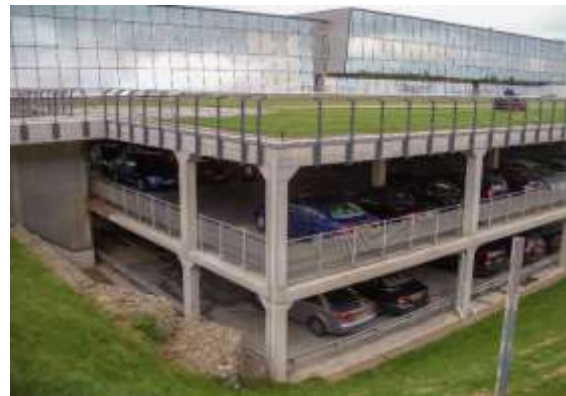
**The Project:** As a result of the vast number of businesses it accommodates, the Arlington Business Park in Reading had endured degradation to its carpark deck and other surrounding features, requiring immediate attention in early 2018. **APA Concrete Repairs Ltd** were contracted to undertake various surveying, concrete repair and re-surfacing works to two of the multi-storey carparks, as well as remedial works to external elements of the surrounding buildings.

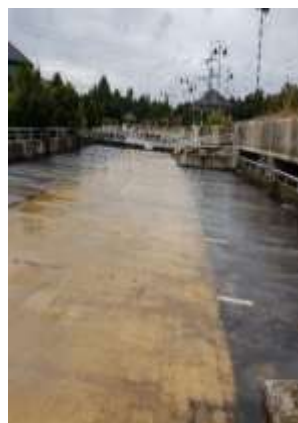
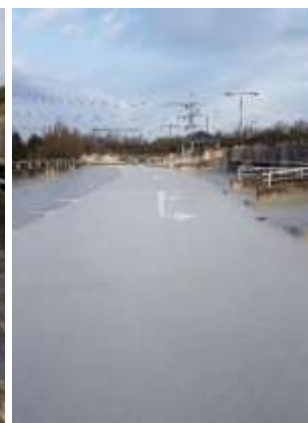
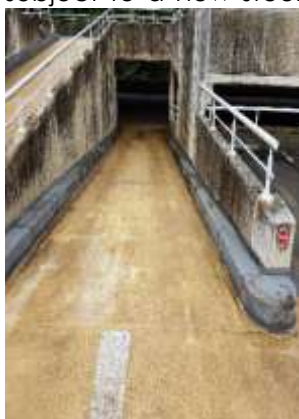
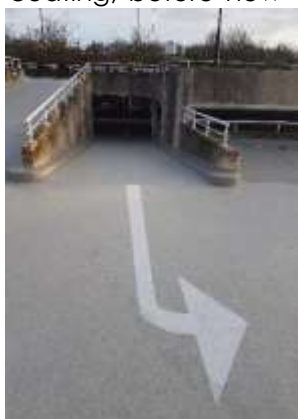
**The solution:** **APA** first developed a surveying proposal with the aim of testing the carpark decks for the presence of chloride concentrations and half-cell potential, resulting in the provision of a value engineered solution of targeted cathodic protection, saving the client approximately £200,000. All identified concrete defects were subject to remediation using suitably selected Sika repair mortars. Exposed faces of the steel plates to the undersides of the slabs were then cleaned and inspected and subject to a new steel coating, before new

drainage pipes/gullies were installed to the base of the ramps. The entire top deck coating of each carpark was removed, hybrid galvanic anodes were installed to each area where high chlorides had been identified, and the deck surfaces were coated with a Tremco MMA Flexible Waterproof System. The perimeter gutter system of the office buildings were re-lined with a liquid applied waterproof system and expansion joints and plasterboard ceilings were replaced.

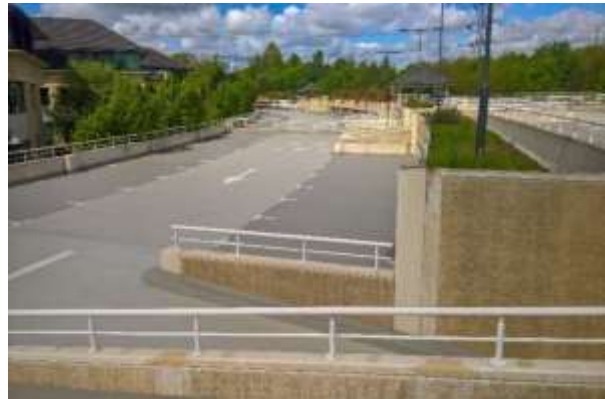
**The outcome:** The refurbishment of Arlington Business Park was completed in April 2018, resulting in a vastly improved car park, complete with enhanced future protection due to the installation of the hybrid cathodic protection system and the new waterproofing system and protective coatings. The office buildings were sealed and made good, enabling the existing businesses to operate unhindered and dry as well as attracting new businesses to populate the accommodation.
