Project Profile: Southampton Road

Project: Southampton Rd Subways - Concrete Repairs

Client: Portsmouth City Council

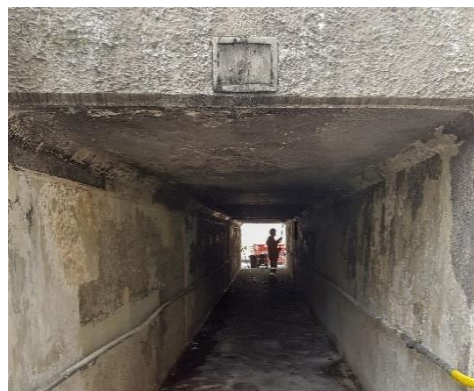
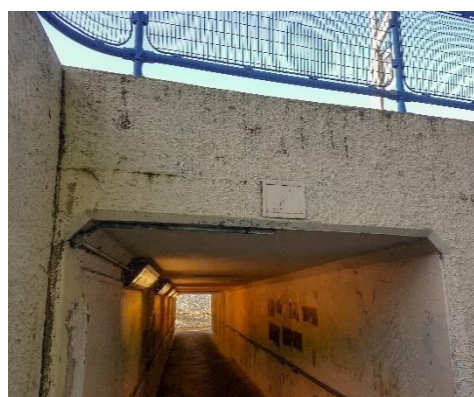
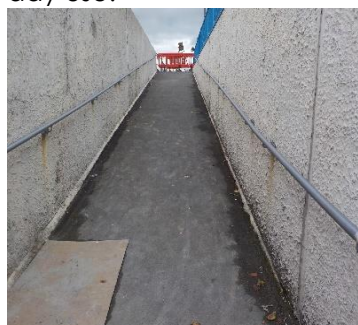
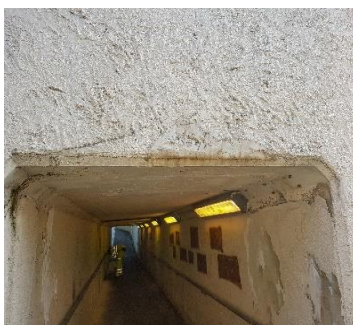
The project: The two Southampton Road subways, located in Portsmouth, were constructed circa 1956 for the purpose of providing pedestrian access under the A3 Southampton Road dual carriageway, comprising a reinforced concrete box structure with a clear square span between the subway walls. A principle inspection of the structures had identified significant cracking, low concrete cover in certain areas and inadequate sealants of joints, amongst other associated defects, as well as extensive fire damage to one of the subways. **APA Concrete Repairs Ltd** were therefore appointed to undertake an extensive refurbishment programme, in order to restore and improve the structures for modern day use.
