Project Profile: Ocean House

Project: Ocean House, Concrete Repairs & Coatings

Client: Orchard Building Ltd

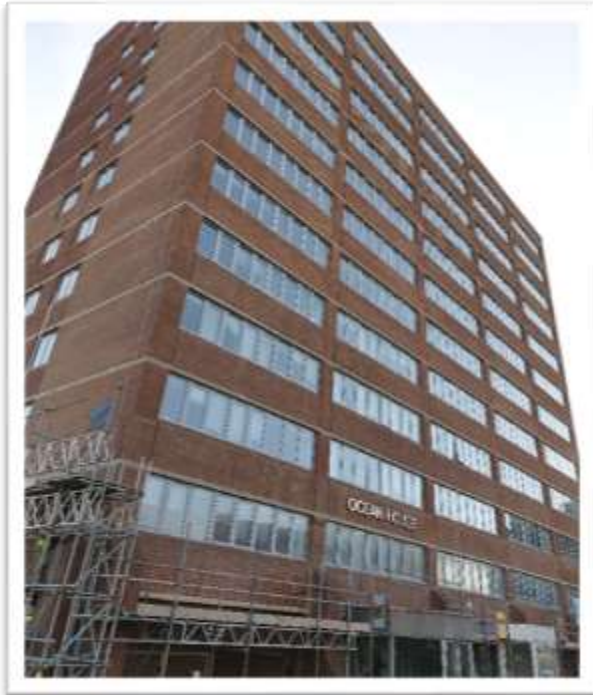
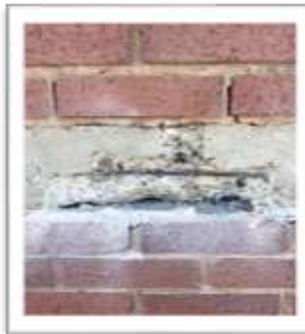
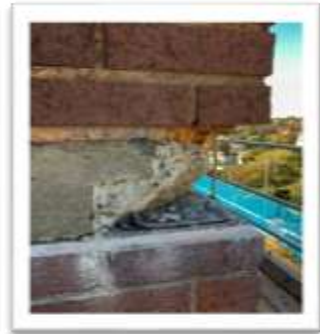
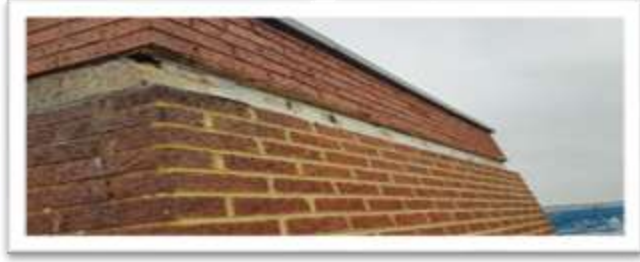
The project: Ocean House, located in St. Leonards on Sea, Hastings, is an open plan office suite just South of the A21 and East of Hastings town centre. The building required an extensive programme of repair and protection works which **APA Concrete Repairs Ltd** were appointed to undertake.

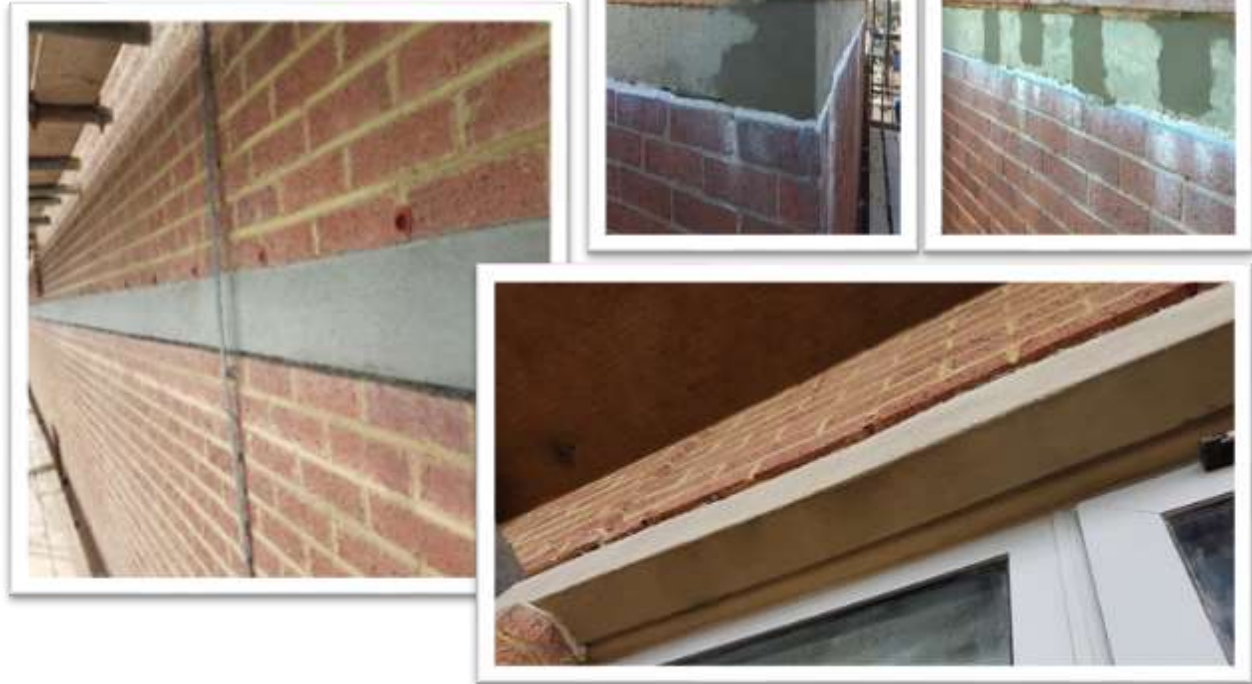
The outcome: The refurbishments to the Ocean House building were completed in October 2018 and provided the much-needed restoration and protection required to surrounding facades, with the coatings applied guaranteeing additional preservation and an extended life cycle of the repairs, with all materials used for the completion of this project provided by Fosroc.
