# Project Profile: RAF Leeming

**Project:** RAF Leeming, Reservoir & Water Tower Repairs

**Client:** Severn Trent Services

**CONCRETE  
REPAIRS**

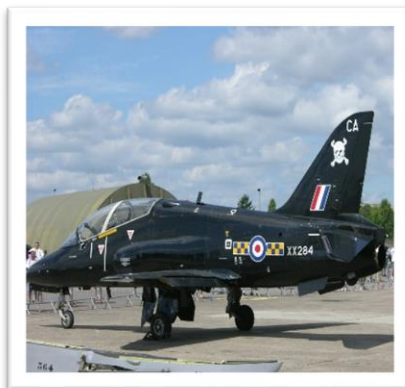
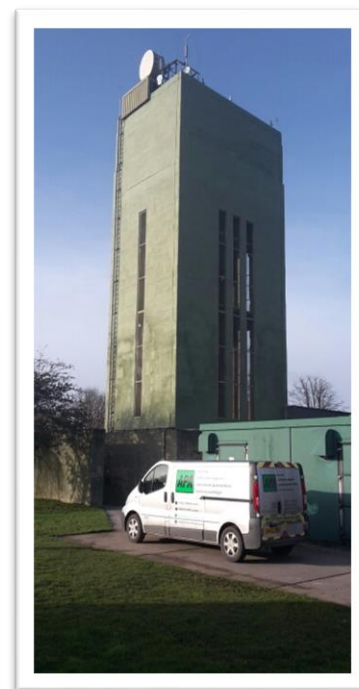
**The project:** Royal Airforce (RAF) Leeming, is a British air force station located near Leeming, North Yorkshire. This RAF station trains, delivers and supports UK and overseas Expeditionary Air Operations. Having been in active use since its opening in 1940, its clear to see why certain structures within this historic station had a need for structural repair and reinforcement. **APA Concrete Repairs Ltd** were therefore contracted to conduct repairs to any internal and external cracking and spalling located on specified structures within the station, as well as rectifying any areas of exposed reinforcement to prevent any further leakage/weeping.
