# Project Profile: Mayorhold Car Park

**Project:** Mayorhold Car Park Refurbishments

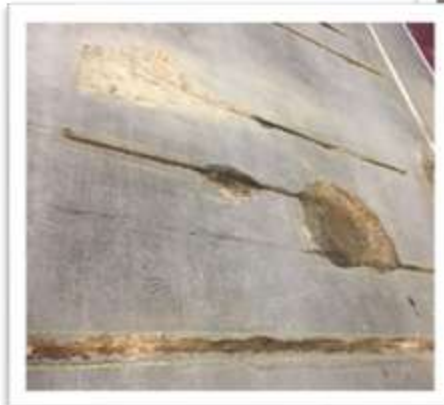
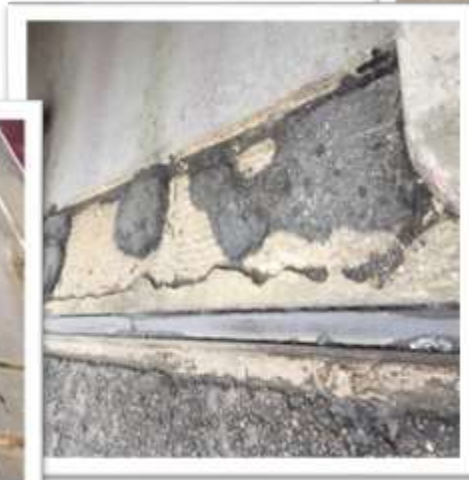
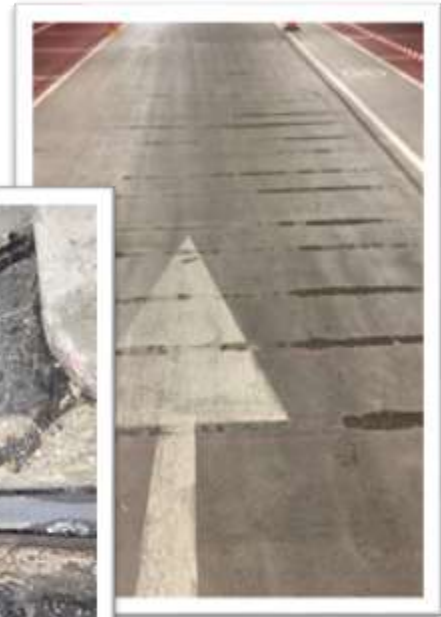
**The project:** The Mayorhold car park is a multi-storey long-stay car park situated in Northampton city centre, containing over 1000 spaces. Originally constructed in 1973, with refurbishment works carried out in 2006, this car park was again in need of remedial attention. **APA Concrete Repairs Ltd** were instructed to survey the car park in early 2018 which identified defects to the top screed of the car park surface which appeared to be of poor quality. As a result, several heavily trafficked areas of the car park had spalled and broken up, in some areas exposing cables and connections of the now defunct cathodic protection system that had been poorly installed in 2006. **APA** were contracted to undertake concrete deck repairs to several levels of this multi-storey car park.
